Culvert Size Classes & Failure Rates Omak Creek Watershed (RMU-13) Colville Indian Reservation, WA

Summary

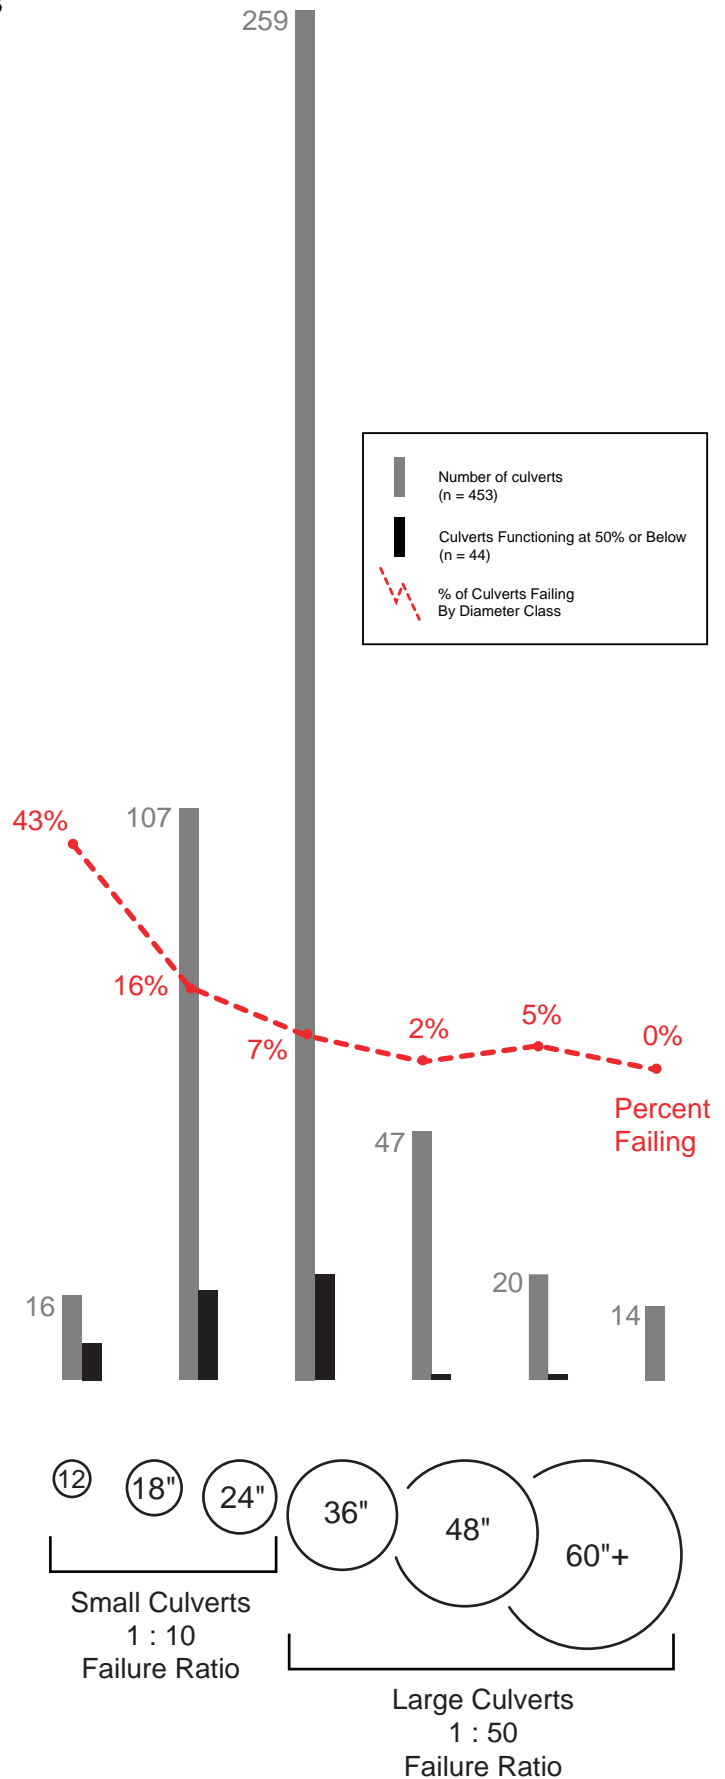
The vast majority (85%) of mapped culverts measured 24" in diameter or less. Failure rates were high for these size classes; 1 in 10 were no longer functional. Large culverts - those with diameters of 36" or more - were far less prone to clogging or fill erosion; one in fifty failed.

We recommend that new culvert be sized at 36" or larger for both BIA System Roads and tribally-managed "Resource Roads".
